The Beaucatcher Mountain Standpipe Failure

By Mark Stevenson, P.E.
Structural Engineer

Ice brings down Asheville's first water tank in 1893

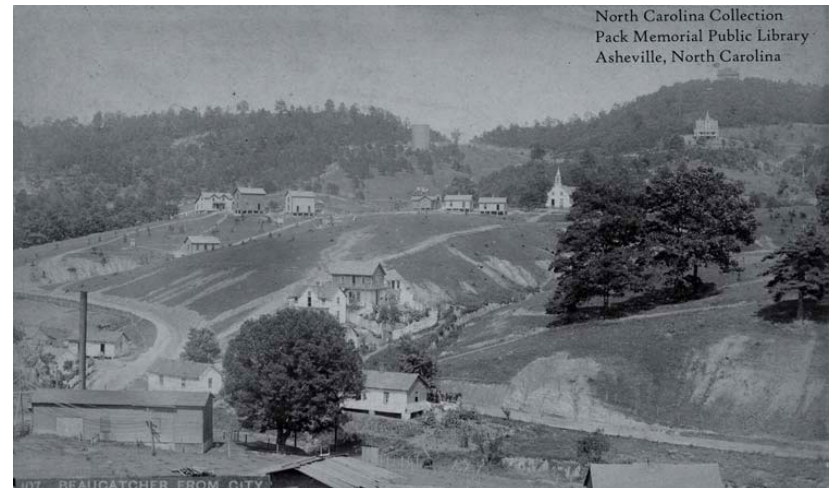
View of Beaucatcher mountain and standpipe, late 1800s

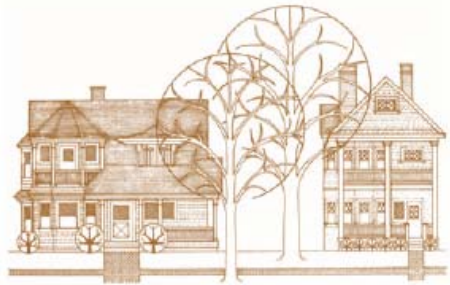
The first tank, or technically a standpipe, was constructed in the winter and spring of 1886–87, as part of improvements to the original central water system first constructed in 1883.

The standpipe was 45 feet in diameter, stood 60 feet tall, and held 713,000 gallons. It was built by Alfred Webb & Co. of Chattanooga, TN, at a cost of \$9,965; the stone masonry foundation cost an additional \$2,000.

Shortly after the erection of the tank was complete, and prior to being filled with water, a strong windstorm collapsed the upper portion of the tank, folding one side in upon the other.

It was reported that the tank was repaired in the following manner: *“The builders secured an eyebolt to the indented portion of the pipe, and, with the aid of a windlass rigged on the slope of the hill, pulled the plates into shape ‘as good as ever’, with only a slight wrinkle remaining to show where the collapse had stopped”.*

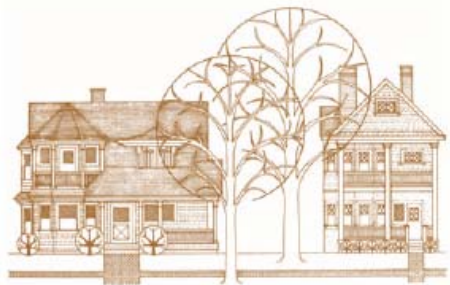
The “slight wrinkle” is evident in a post-card picture published by T. H. Lindsey. The tank operated more-or-less trouble free for the next 4 years, although the water level in the tank rarely exceeded half its height. With the tank only partially full, the negative effects of the wind continued to be problem.

Residents observed the sides of the tank vibrating violently in the wind, causing a loud rattling sound. This condition continued until 1891 when the wind caused a break to occur in the steel angle that se-cured the base of the tank to the foundation. The broken angle was not repaired, although guy wires were attached to the tank to reduce the vibrations.

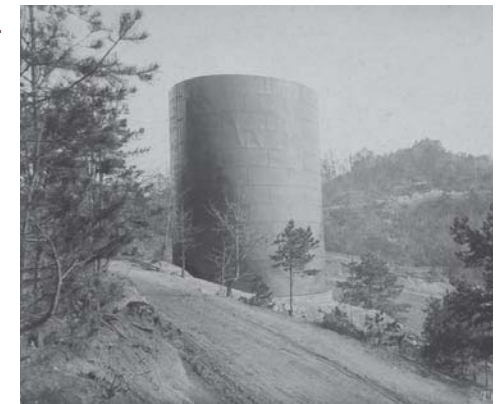
Photo Showing “Slight Wrinkle” In Standpipe
